YOUR FIDELIS HOME INSPECTION REPORT

Isac Enriquez

Fidelis Home Inspection
1830 W 17th St, Suite 2F
Chicago, IL 60608

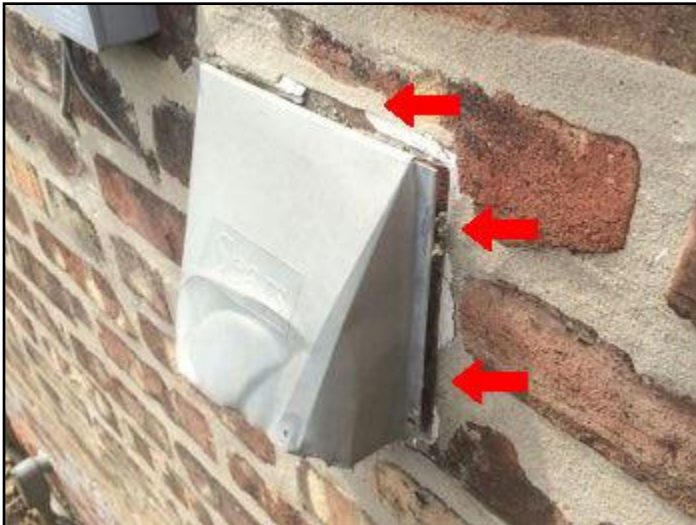
Exterior vent cap(s) appeared to be missing caulking and not securely attached to the wall

10. East wall vent cap

Task: Repair or replace

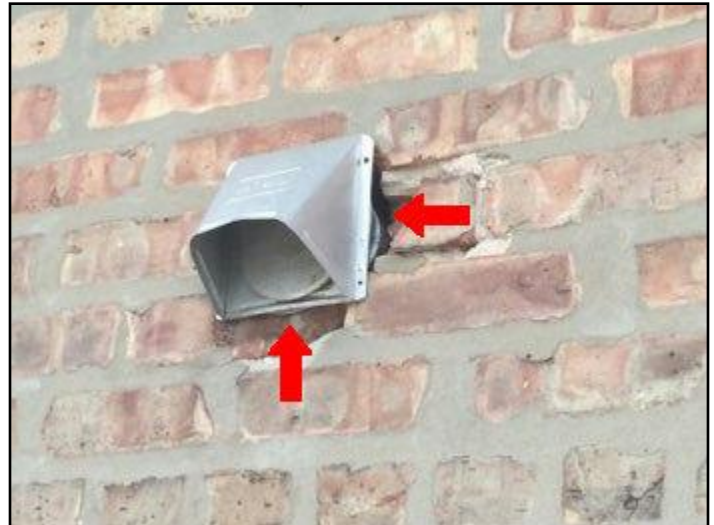
11. West wall vent cap

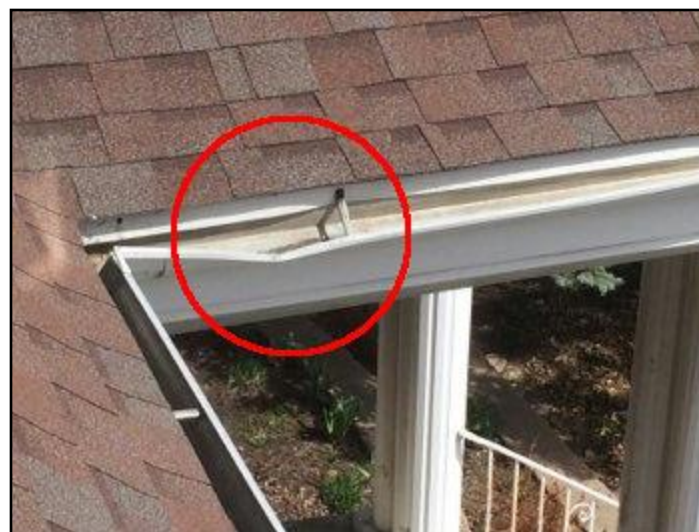
Gutter appeared to be damaged and at an improper slope

Implication(s): Chance of water damage to contents, finishes and/or structure

12. Damaged gutter w/ improper slope

Task: Repair or replace

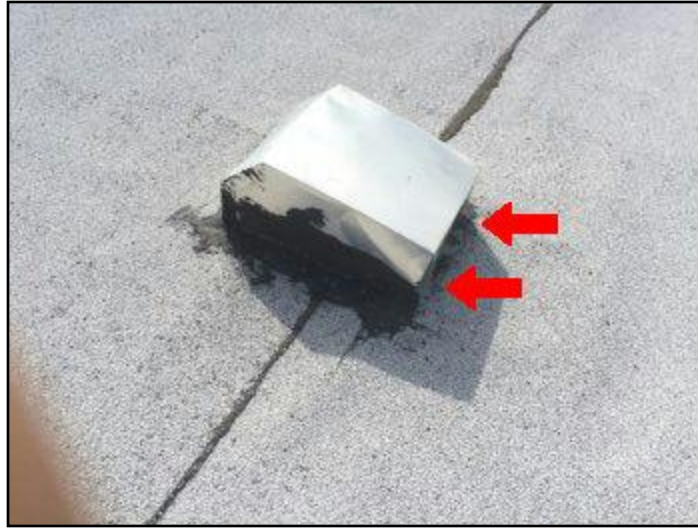
Flat roof vent appeared to have improper flashing. Flashing should overlap flat roll roofing.

Implication(s): Chance of water damage to contents, finishes and/or structure

13. Improper flashing

Task: Correct

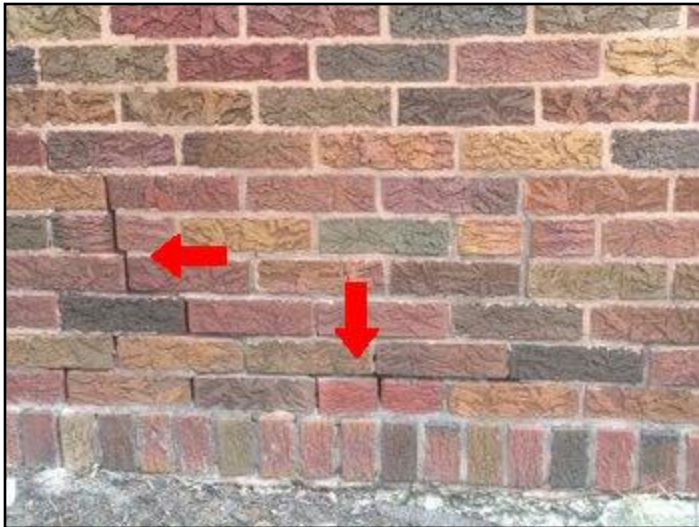
The southeast corner of the structure appeared to have heaved up causing cracks. There also appeared to be cracks under the window sill on the east wall.

14. Cracked south wall

Task: Monitor

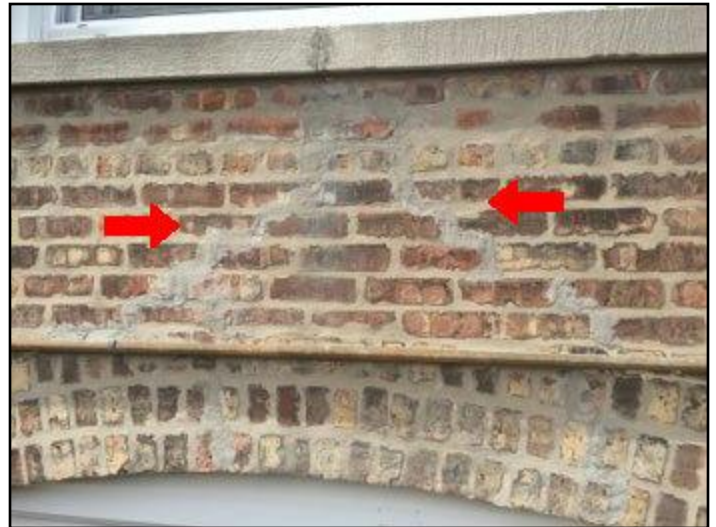
15. Cracked east wall under window sill

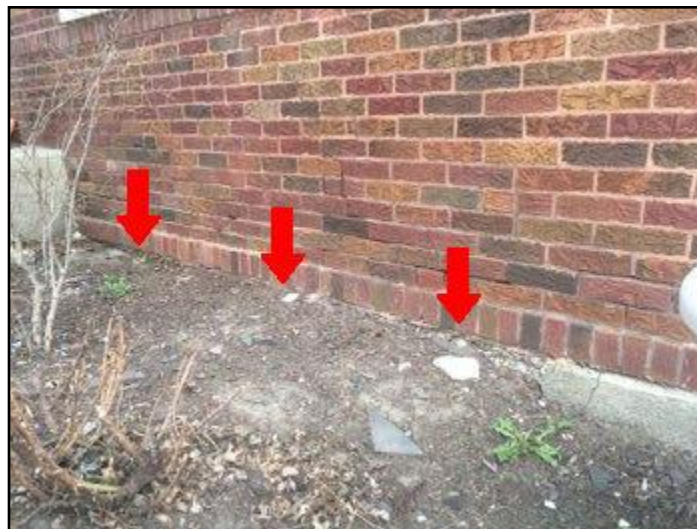
Implication(s): Chance of water entering building | Weakened structure | Rot

16. Too close to grade

Task: Repair

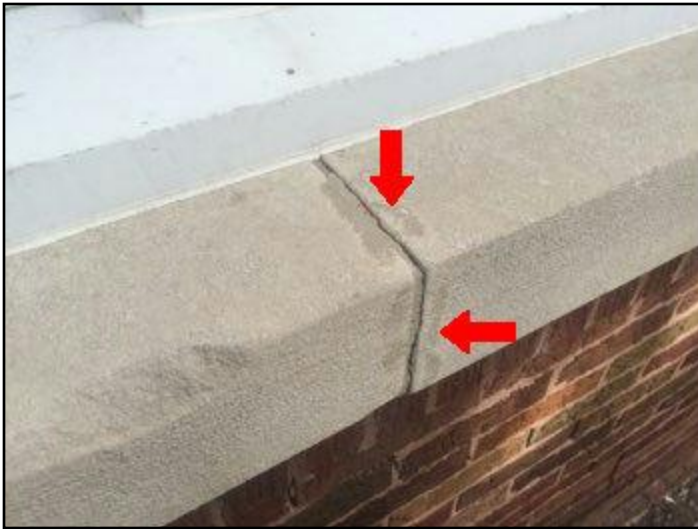
There appeared to be missing caulking at various locations on the exterior

17. Caulking missing at window sill(s)

Task: Improve

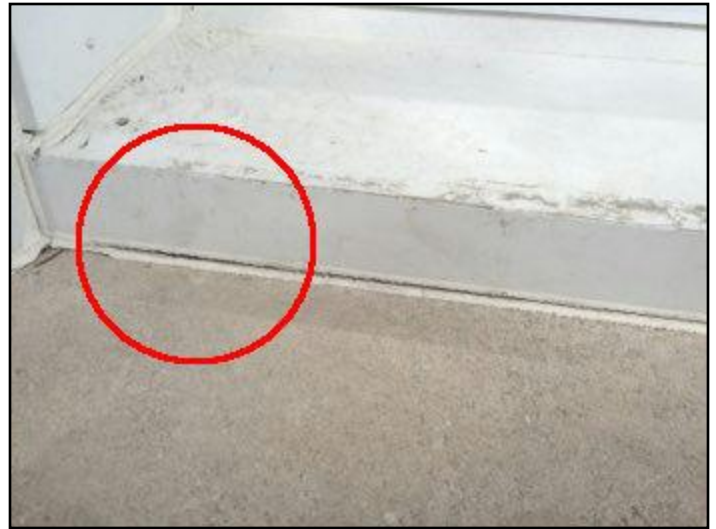
18. Caulking deteriorated at various windows

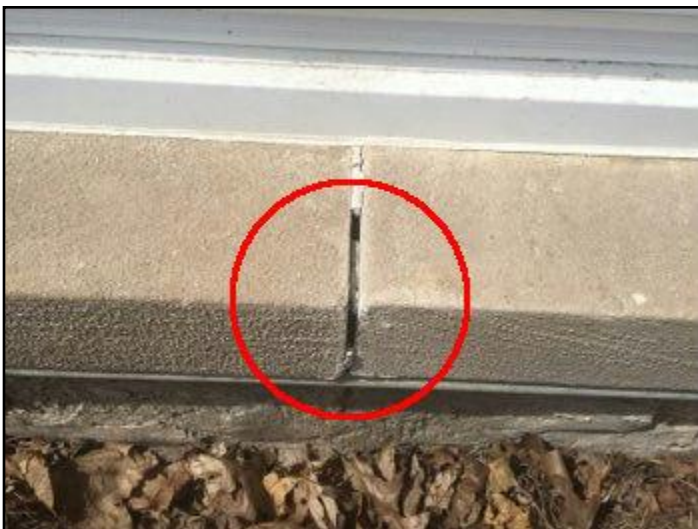
19. Caulking missing at window sill(s)

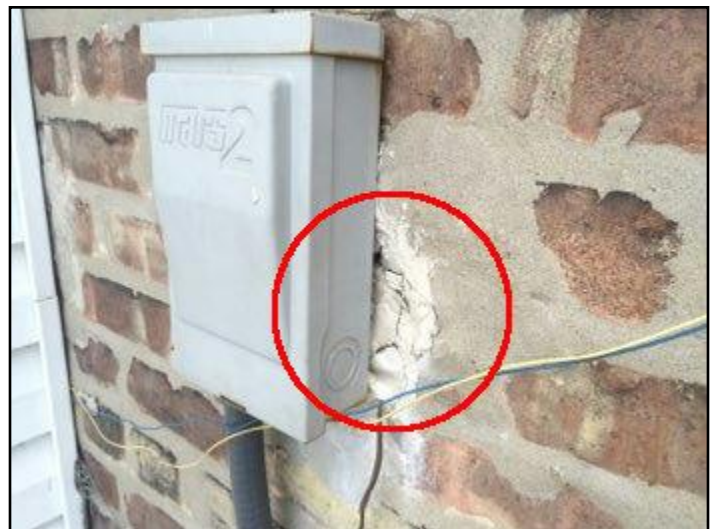
20. Caulking deteriorated at A/C disconnect

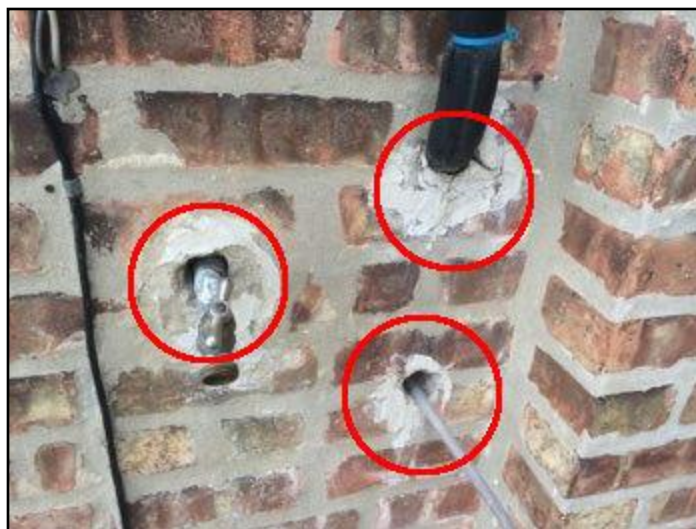
21. *Caulking deteriorated*

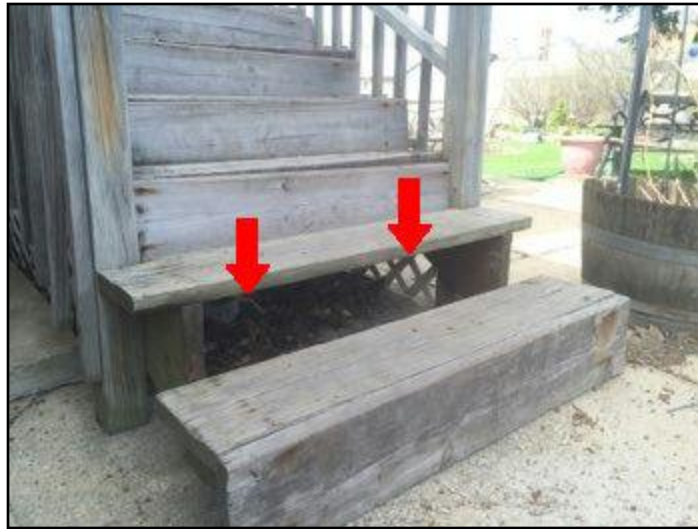
Rear steps appeared to be missing a riser, posing a potential trip hazard

Implication(s): Trip or fall hazard

22. Trip hazard at rear steps

Task: Repair or replace

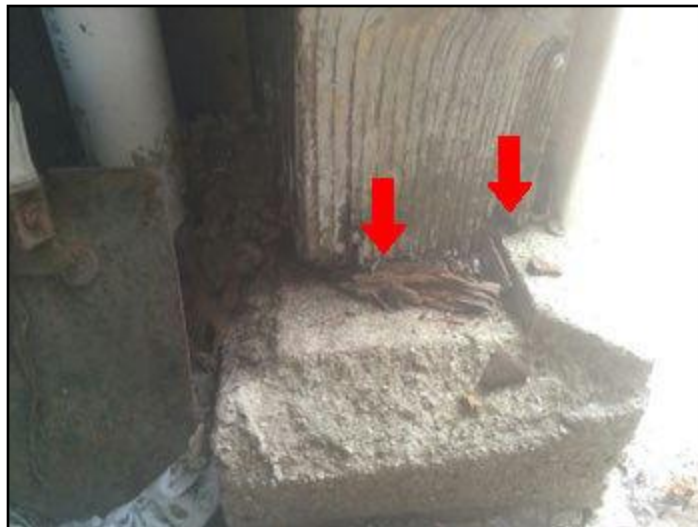
Implication(s): Weakened structure | Material deterioration

23. Rot at support post

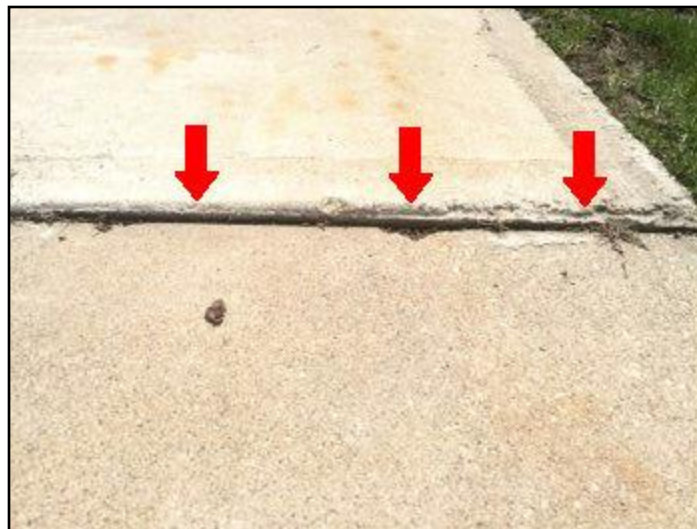
11. Condition: • [Uneven \(trip hazard\)](#)

24. Uneven (trip hazard) at driveway

Task: Repair or replace

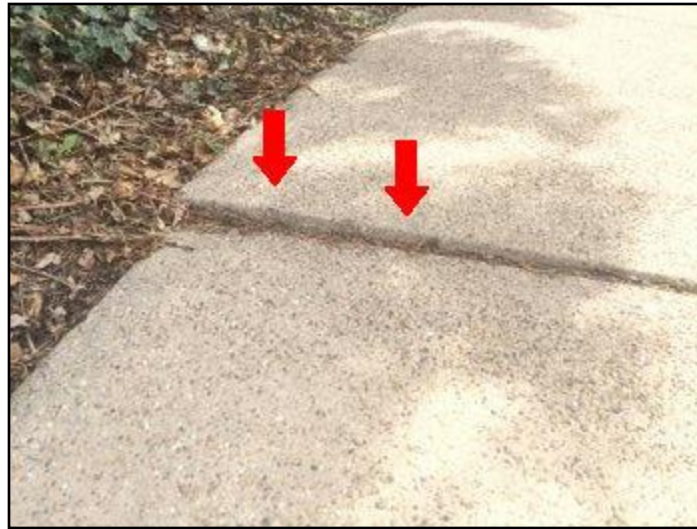
12. Condition: • [Uneven \(trip hazard\)](#)

25. Trip hazard at walkway

Task: Repair or replace

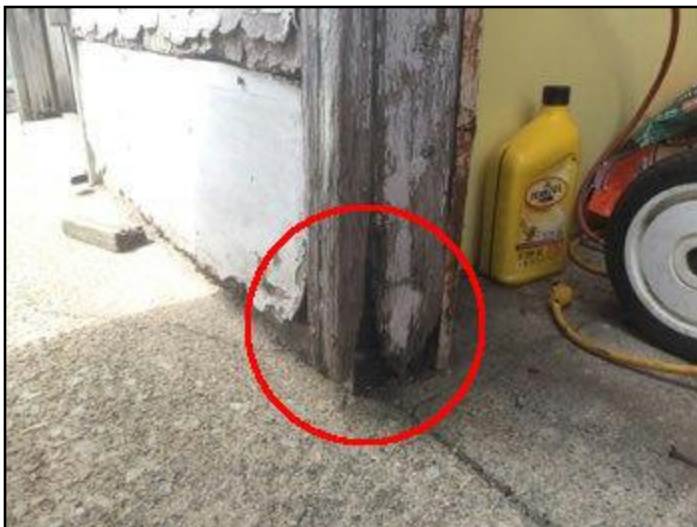
There appeared to be rot and deterioration at various locations at exterior garage walls

26. Rot at vehicle entry doorway

Task: Repair or replace

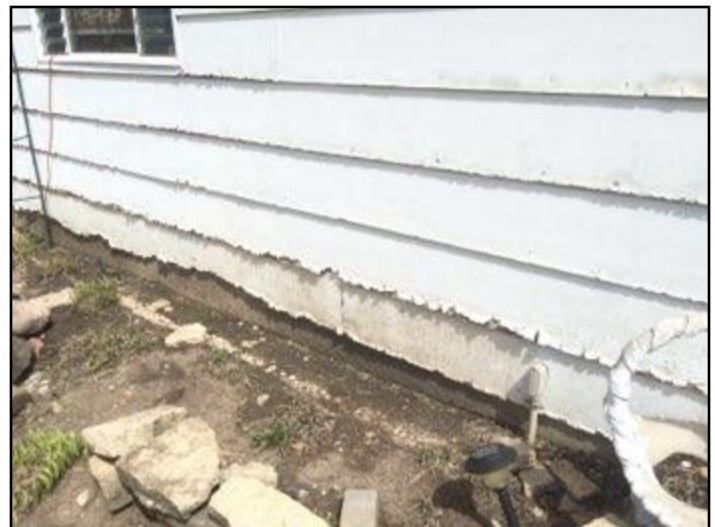
27. Rot at exterior wall

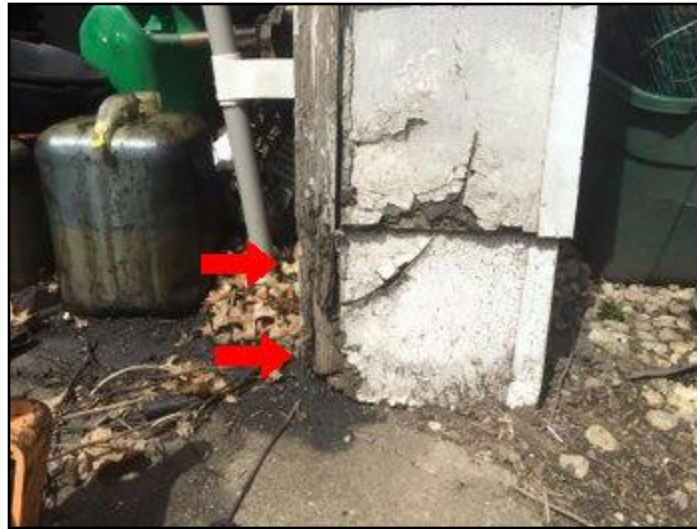
28. Rot at vehicle entry doorway

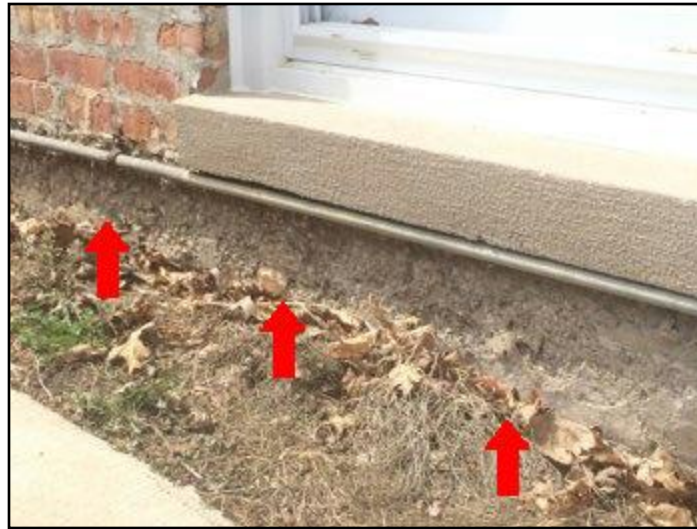
16. Condition: • [Spalling, crumbling or broken material](#)

29. Spalling and crumbling cement at foundation

Task: Repair or replace

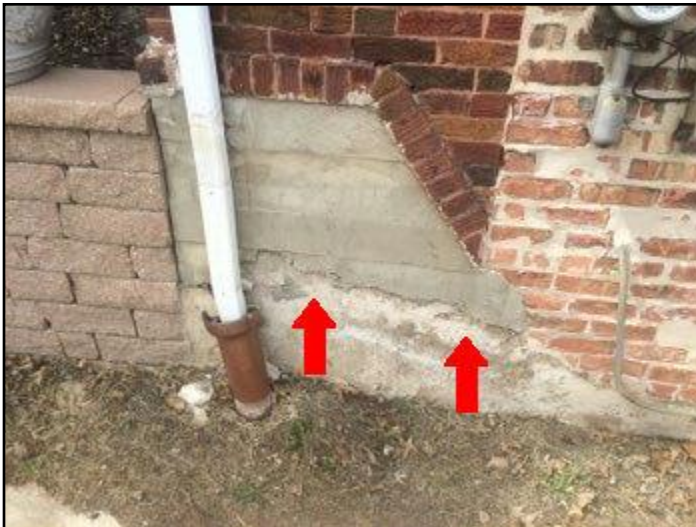
Parging damaged at various locations

Implication(s): Chance of damage to structure | Shortened life expectancy of material

30. Parging damaged

Task: Repair or replace

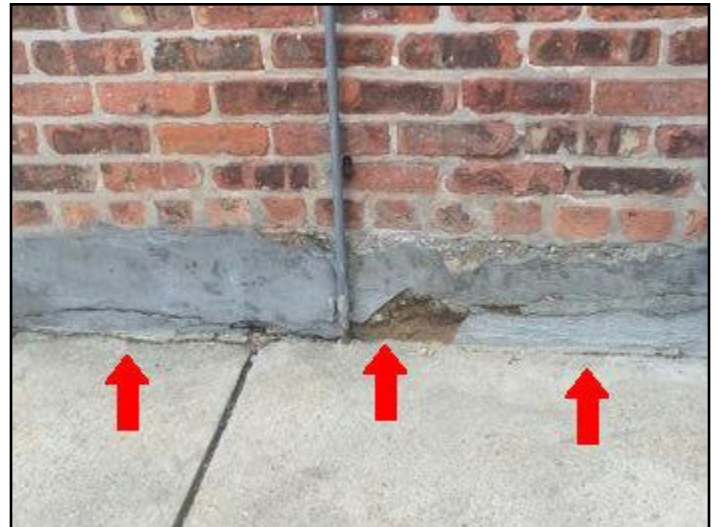
31. Parging damaged

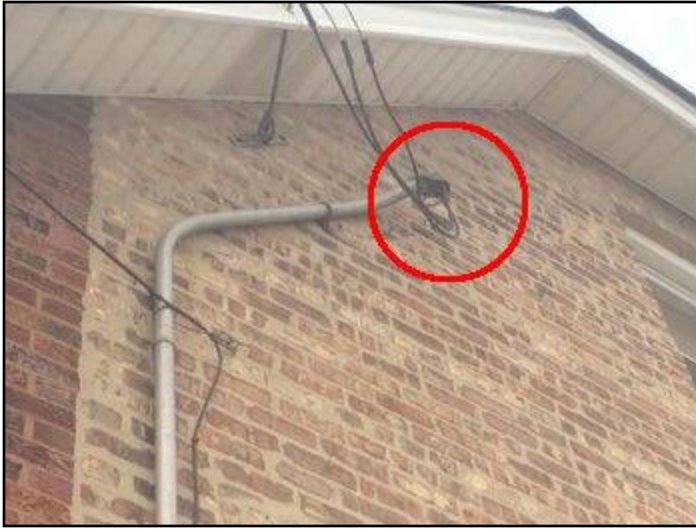
18. Condition: • Service entrance anchors appeared loose and disconnected from wall

33. Service entrance pulled away from wall

Task: Repair

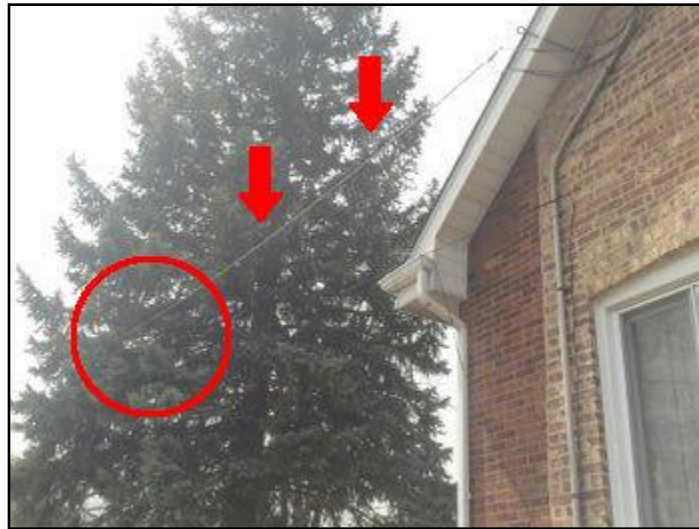
19. Condition: • [Branches, vines interfering with wires](#)

Implication(s): Damage to wire | Electric shock | Interruption of electrical service

35. Branches, vines interfering with wires

Task: Improve

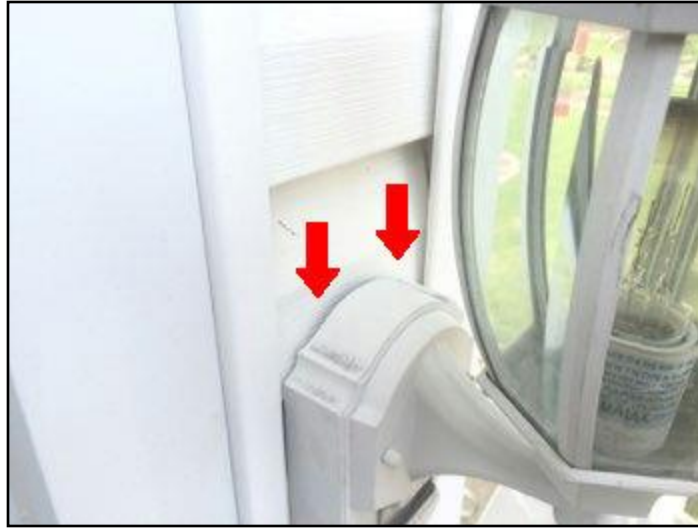
20. Condition: • Exterior light appeared to be missing caulking

36. Missing caulking at exterior light

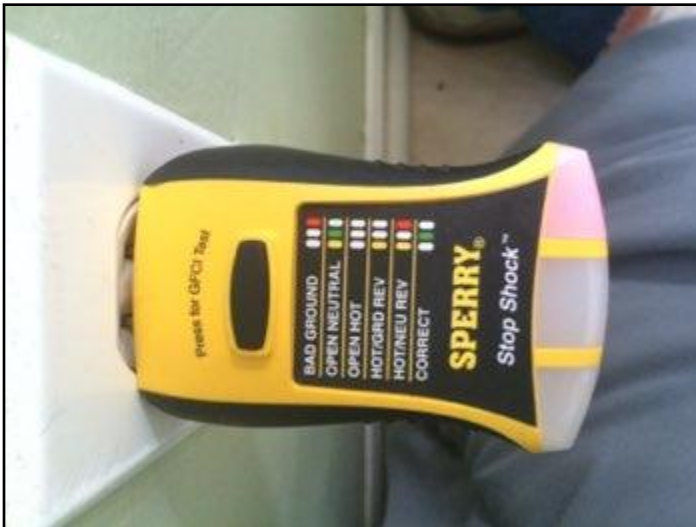
21. Condition: • Outlet(s) appeared to have a bad ground

37. Bad ground

Task: Repair or replace

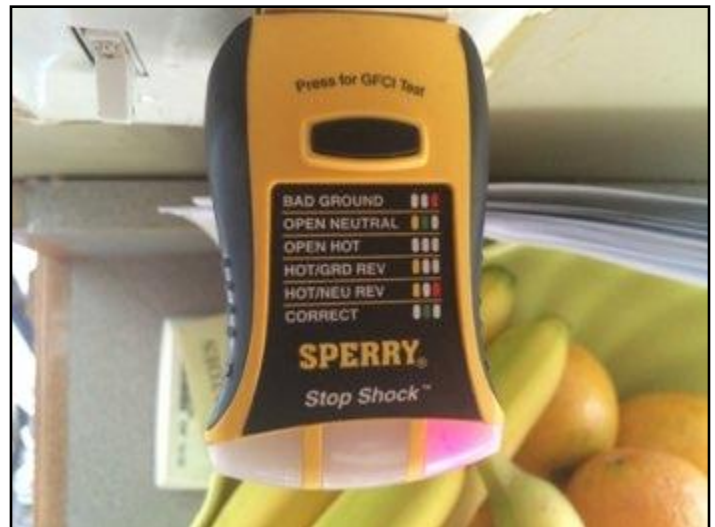
38. Bad ground

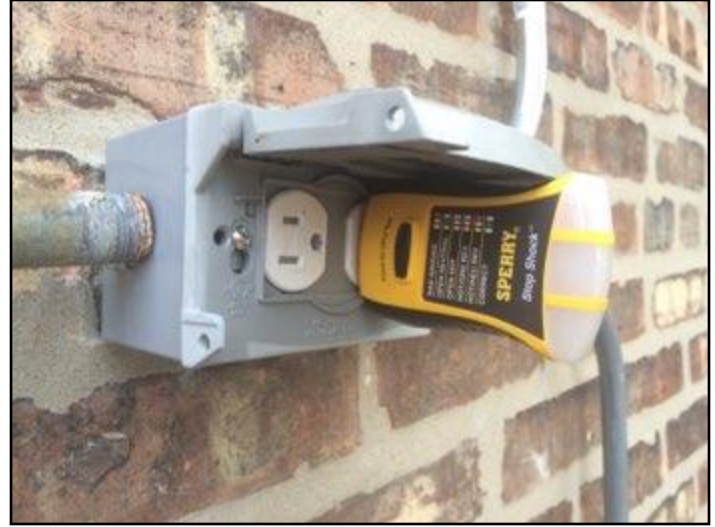
22. Condition: • [Inoperative](#)

40. Inoperative exterior outlet

Task: Repair or replace

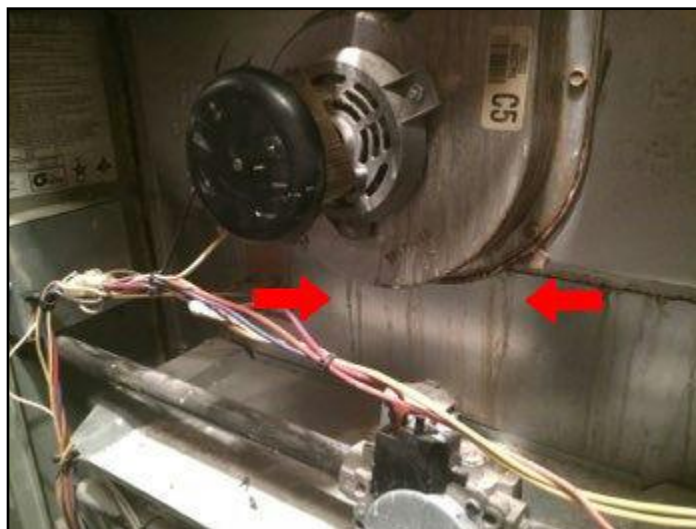
There appeared to be rust in the interior furnace cabinet

Implication(s): Material deterioration | Reduced system life expectancy**Location:** Basement Utility Room p**Task:** Monitor**Time:** Ongoing

45. Rust in furnace cabinet

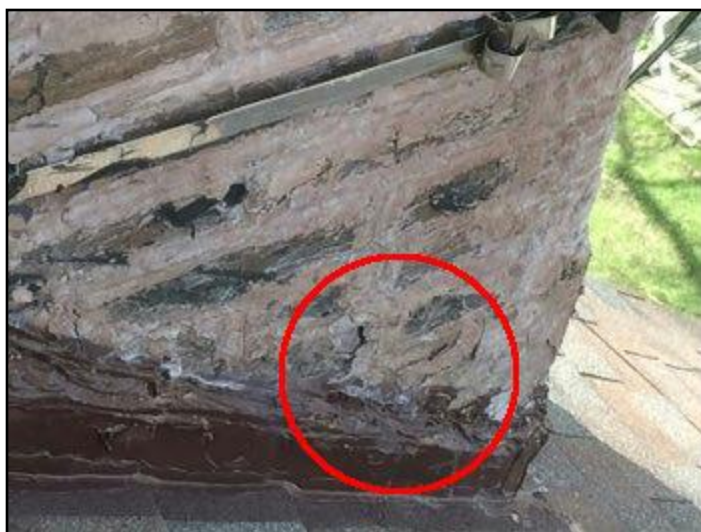
Chimney chase appeared to be spalling and showed signs of previous patching repairs

46. Spalling

Implication(s): Material deterioration**Location:** Exterior**Task:** Repair or replace**Time:** Immediate

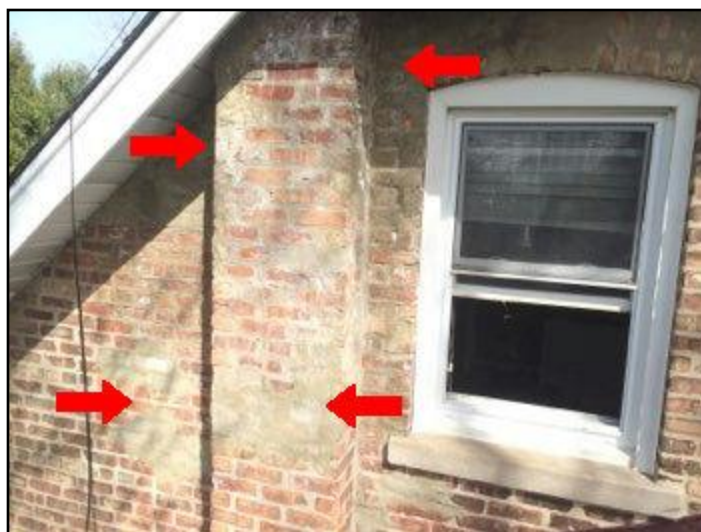
47. Parging repairs

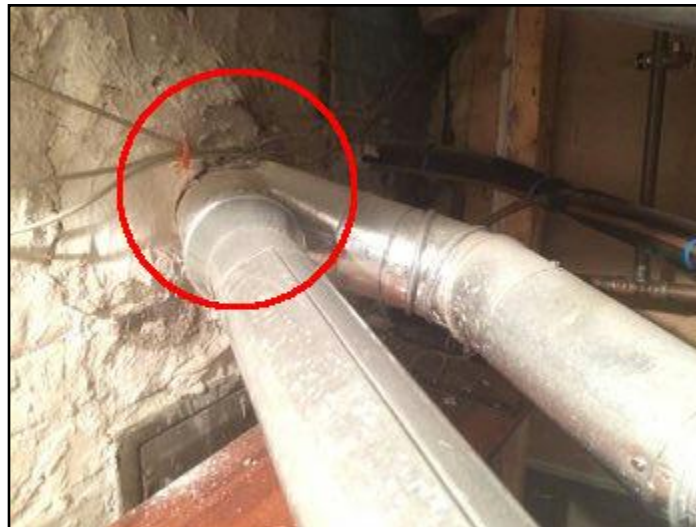
27. Condition: • Appliance vents appeared to be parallel instead of stacked, larger appliance vent above smaller vent.

49. Appliance vents into chimney flue

Task: Repair or replace

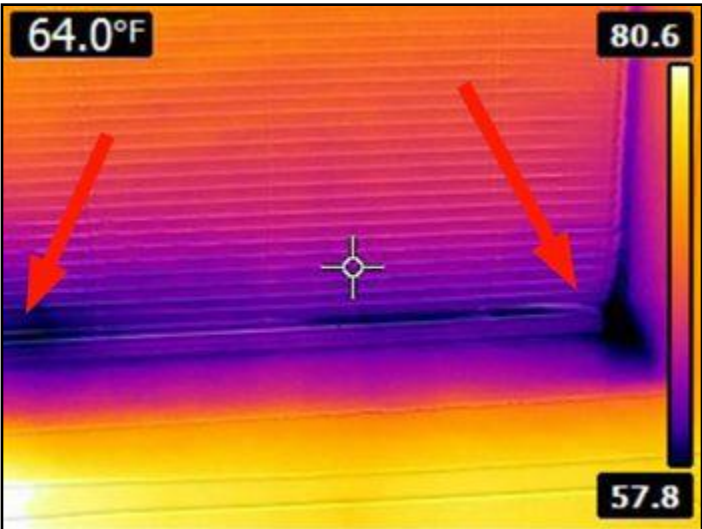
28. **Condition:** • Cold/hot air intrusion may lead to energy loss and affect comfort level in surrounding area

53. Cold/hot air intrusion at window

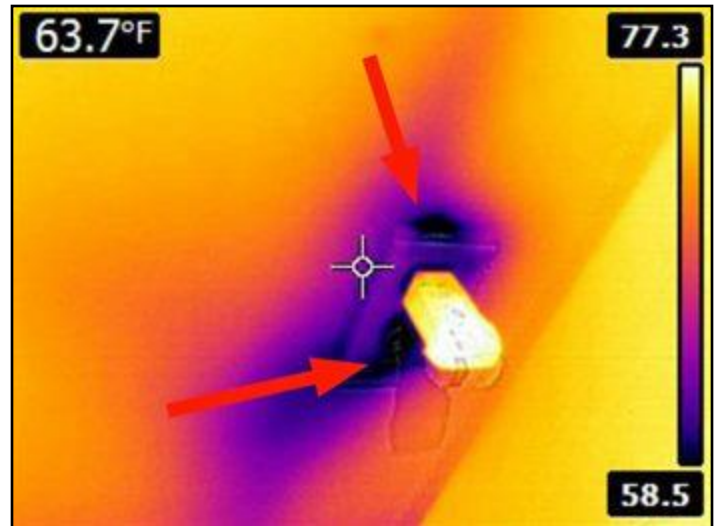
55. Cold/hot air intrusion at outlet

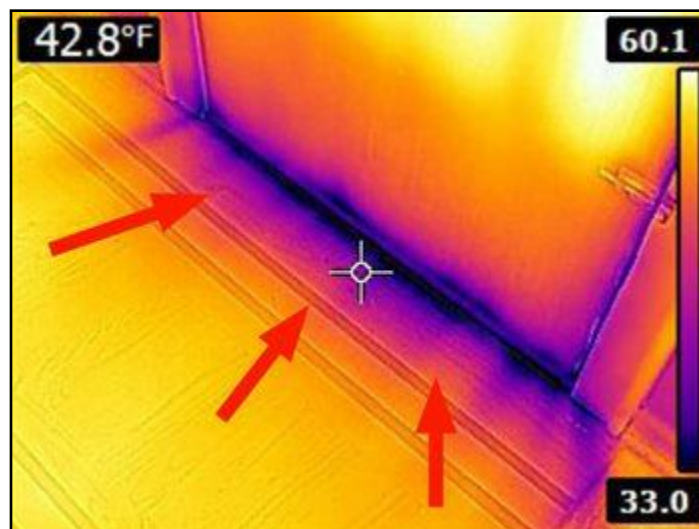
56. Cold/hot air intrusion at door

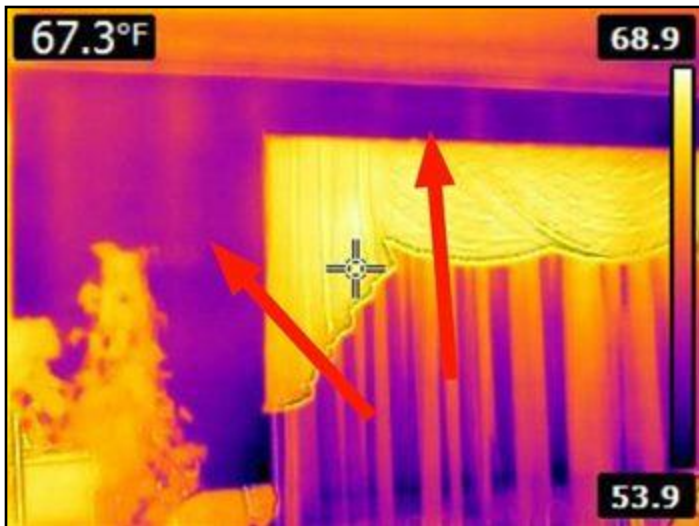
There appeared to be missing insulation at various exterior walls

57. Missing insulation on exterior wall

Task: Provide

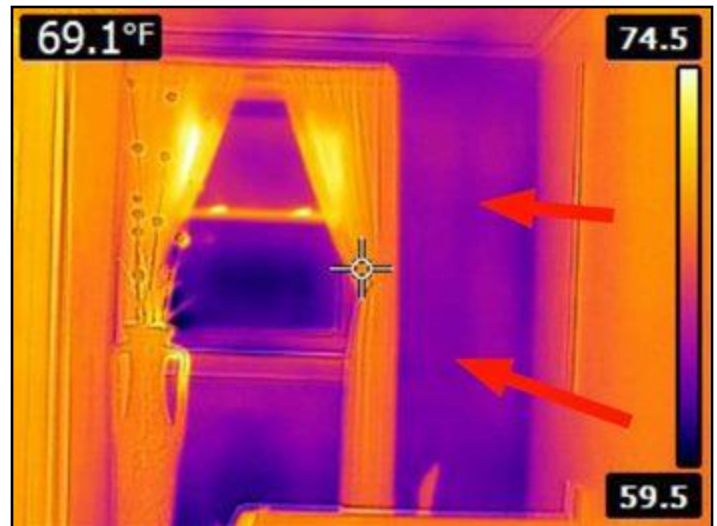
58. Missing insulation on exterior wall

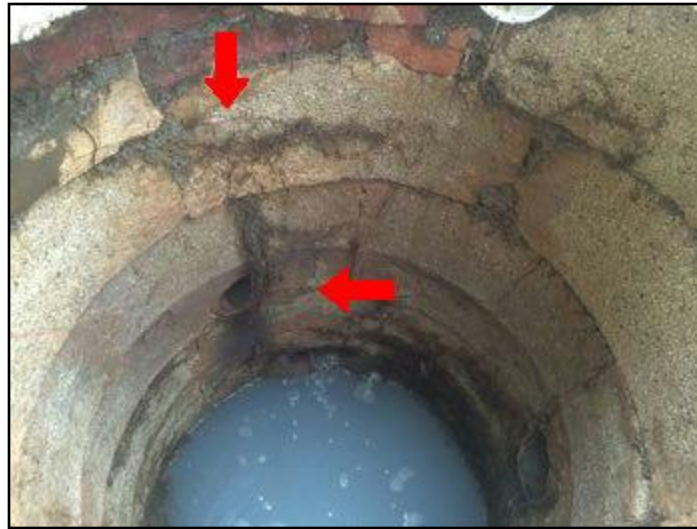
30. Condition: • Catch basin appeared to have roots growing through its walls. Recommend rodding at intervals when needed

63. Root growth at catch basin

Task: Service

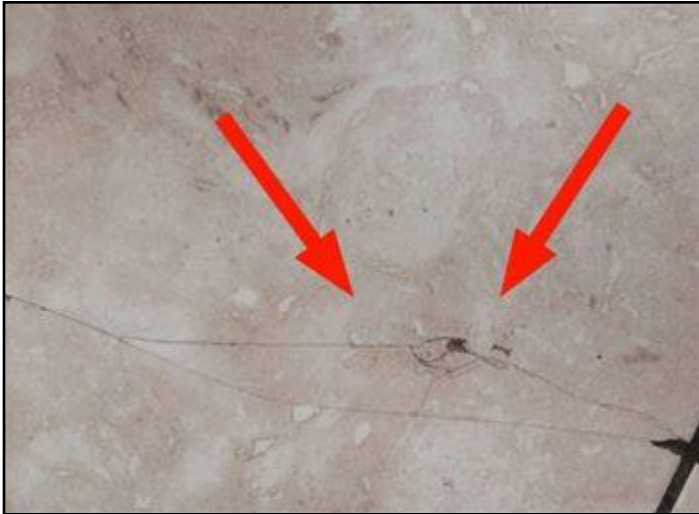
Tiles appeared to be cracked

71. Tiles cracked

Task: Repair or replace

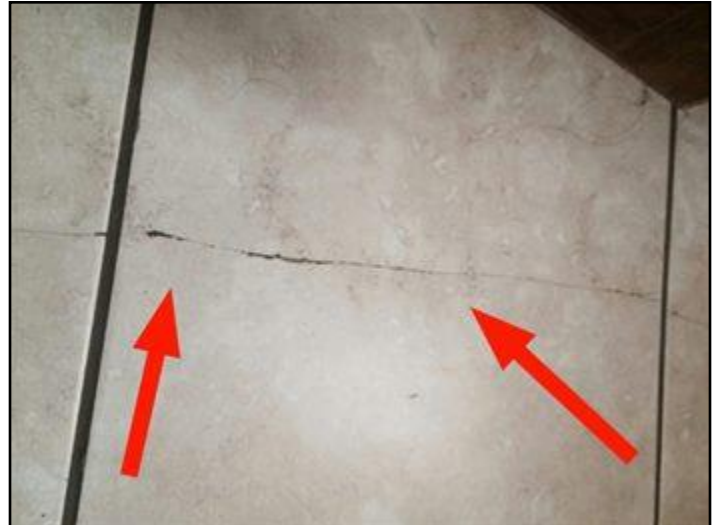
72. Tiles cracked

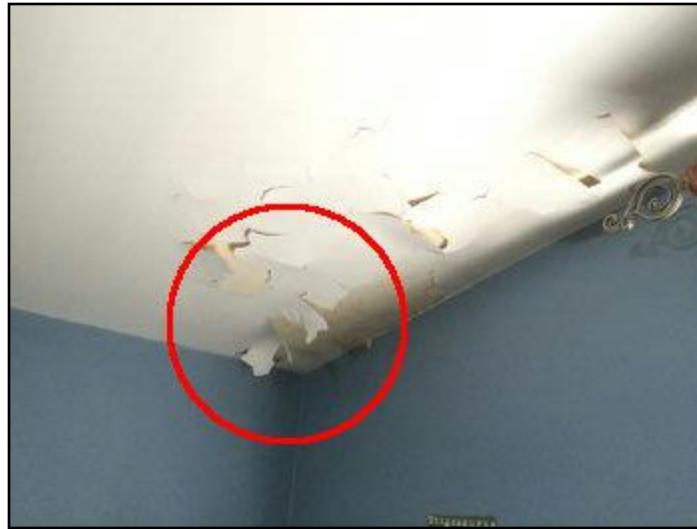
Bedroom ceiling appeared to be water damaged and peeling

73. Crumbly or powdery

Task: Repair or replace

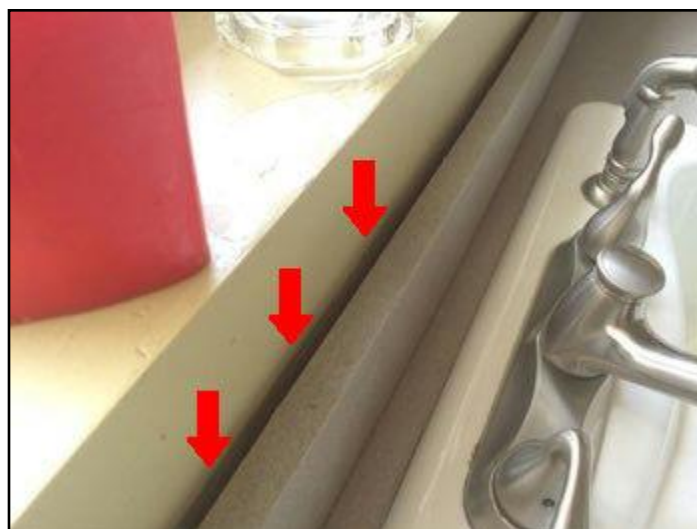
Countertop trim appeared to be loose and had a visible gap. This may increase chance of moisture intrusion behind trim.

74. Gap at countertop trim

Task: Repair or replace

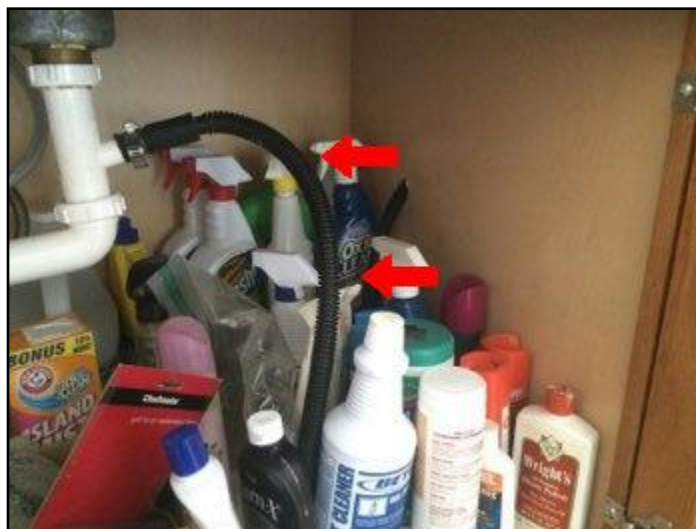
39. Condition: • Backflow prevention missing

75. *Backflow prevention missing*

Task: Provide

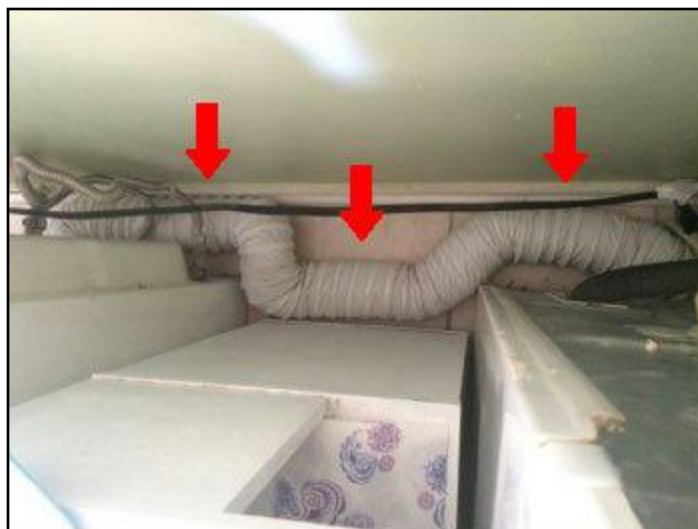
40. Condition: • Plastic dryer vent

76. Plastic dryer vent

Recommend replacing plastic dryer vent for metal vent
