YOUR FIDELIS HOME INSPECTION REPORT

Isac Enriquez

Fidelis Home Inspection
1830 W 17th St, Suite 2F
Chicago, IL 60608

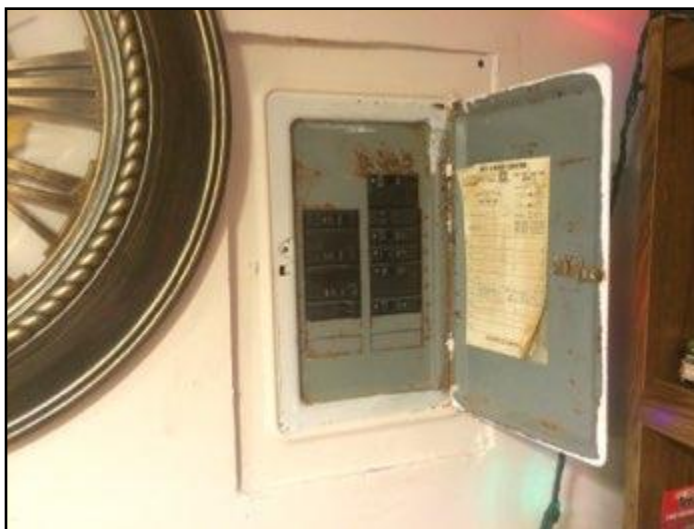
32. Breakers - basement

Breaker box appeared to be sealed by drywall

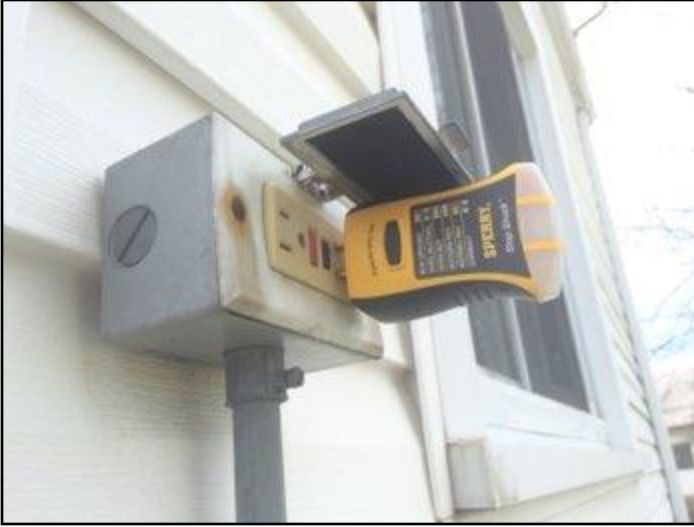
39. Inoperative exterior outlet
